ASSESSMENT OF FAILURES OF POST-FRAME BUILDINGS IN NEW YORK STATE DUE TO SNOW LOAD

C.A. Gooch, P.E. and K.G. Gebremedhin
Senior Extension Associate and Professor, respectively, Dept. of Ag. & Bio. Eng.
Cornell University, Ithaca, NY 14850

Written for Presentation at the
1999 ASAE/CSAE-SCGR Annual International Meeting
Sponsored by ASAE

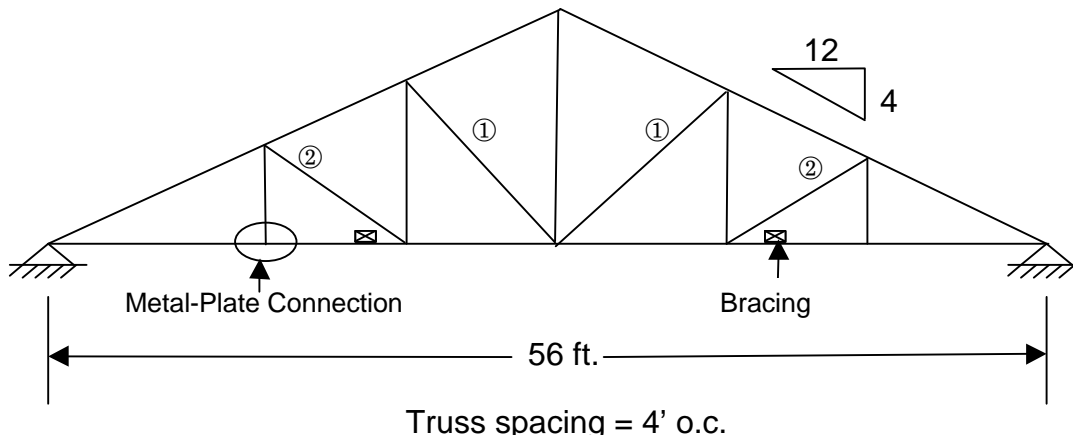
Based on significant visible lateral deflections of the compression web and bottom chord members of the trusses in the original building, the fire department was called in to shovel the roof. Twenty to thirty men worked for several hours to remove snow from the roof. A large volume of snow on the upper roof was transferred to the lien-to addition roof causing increased loading. A barn employee recalled hearing creaking and groaning in the area of the lien-to addition and reported this to the shoveling crew. Efforts were re-directed towards shoveling snow from the lien-to roof and it was saved.

The truss configuration of the original building is shown in Figure 2. Top and bottom chords were 2x8's and web members were 2x4's. Trusses were spaced 4 ft. on center. The owner commented that the web members marked ① deflected approximately one foot out-of-plane and those members marked ② also deflected significantly. The calculated slenderness ratios for the web members marked ① and ② are 90 and 79, respectively. These values exceed the allowable limit of slenderness ratio of 50 (National Forest Products Association, 1991). Lateral bracing of these members would be appropriate to reduce the unsupported buckling length.

Figure 2. Truss configuration of the original truss for Case No. 1.

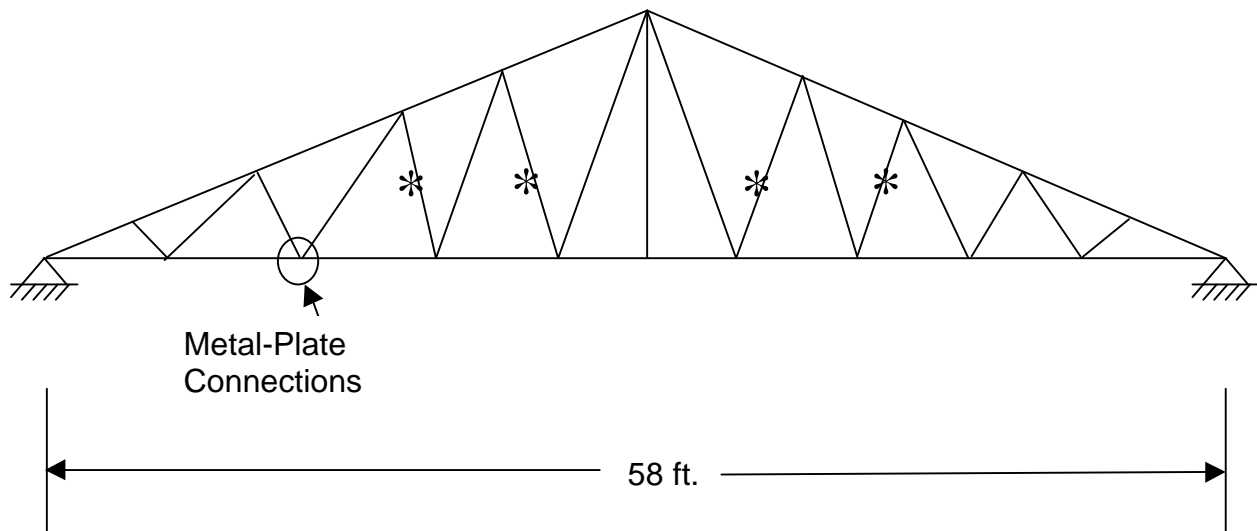
The truss configuration of the new addition is shown in Figure 3. Top chords are 2x12's, bottom chords are 2-2x6's stacked on edge, starred (*) web members are 2-2x6's and the rest are 2x4's. These trusses were spaced 10 ft. on center. Visual observation showed that the trusses lack bottom chord, web, and diagonal bracing members.

Figure 3. Truss configuration of new addition for Case No. 1.

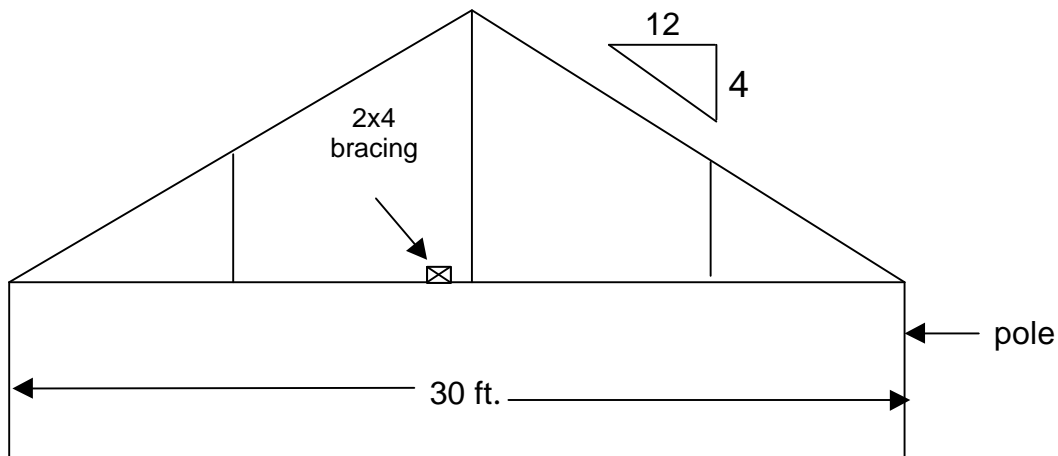
In the original truss configuration, under ideal vertical conditions of the truss, the center and the other two vertical web members are zero force members (Figure 4a). This means that no force is transferred by these members from the top chord to the bottom chord. Hence, the truss can be considered as one big triangle.

Figure 4a. Truss configuration for Case No. 2.

The remedy employed by the building owners changed the load transfer mechanism of the trusses. By placing the 2-ply posts directly under the center vertical web member, the center web member now carries the sum of the vertical components of the top chords at the ridge. This puts the center web member in compression, a load that it was not originally designed to carry.

The bottom chord lateral bracing was originally at mid-span only and was not moved after the center posts were put in place. No diagonal bracing existed on the roof.

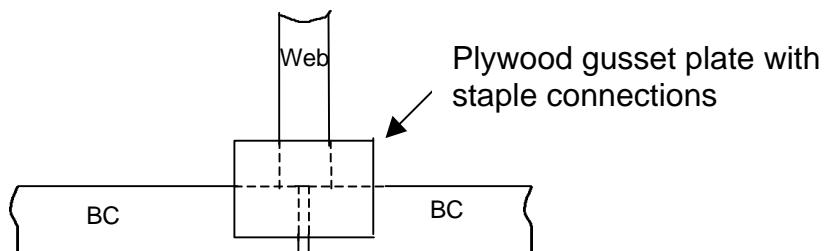
Figure 4b. Bottom chord connection for Case No. 2.

The tension splice of the bottom chord was at mid-span of the truss. The strength of the connection was entirely dependent upon a few nails connecting the gusset plate to the bottom chord, and the strength of the nails was compromised by corrosion because of the moisture-laden environment.

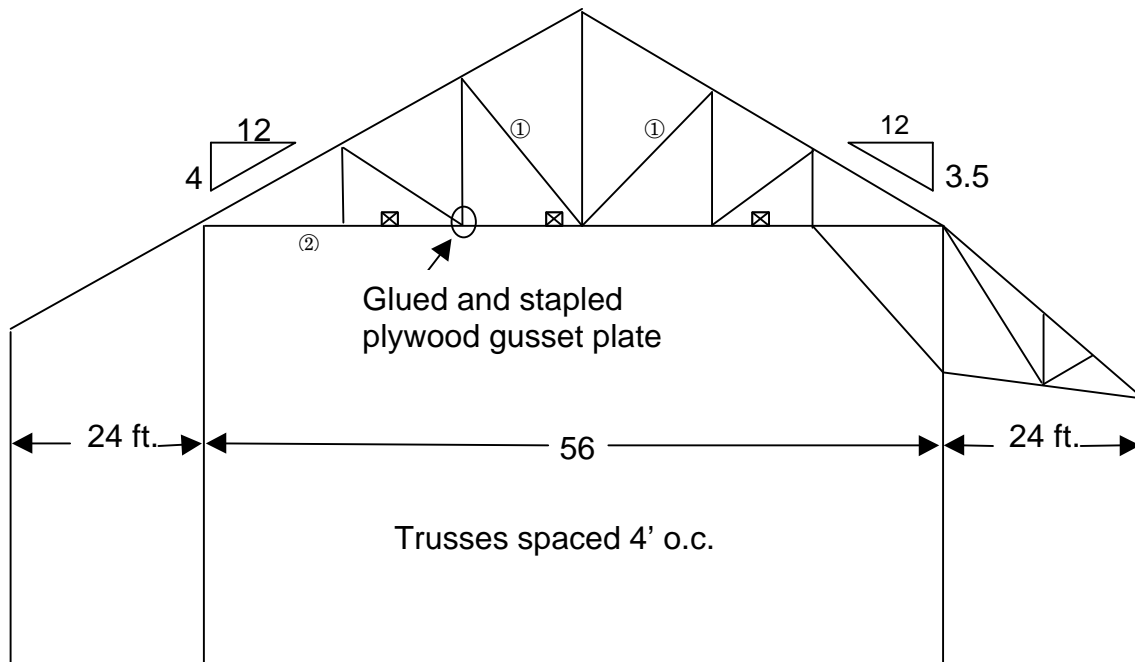
The collapse of the trusses seemed to have originated at the web members marked ①. These members failed by buckling under the heavy snow load. The connections marked ② on Figure 5 were also separated. The slenderness ratios of the compression web members marked ① were greater than 50. Installation of appropriate lateral bracing on these members would have reduced the buckling length to an acceptable

value. The owner of the building indicated to us that they had constructed the original building with farm labor.

Figure 5. Truss configuration for Case No. 3.

The producer expressed his disappointment about the failed building, yet he failed to recognize the need to install lateral bracing in the new trusses despite the fact that he was provided instructions by the truss manufacturer describing how to do so. Again farm labor was used to set the trusses and make repairs.

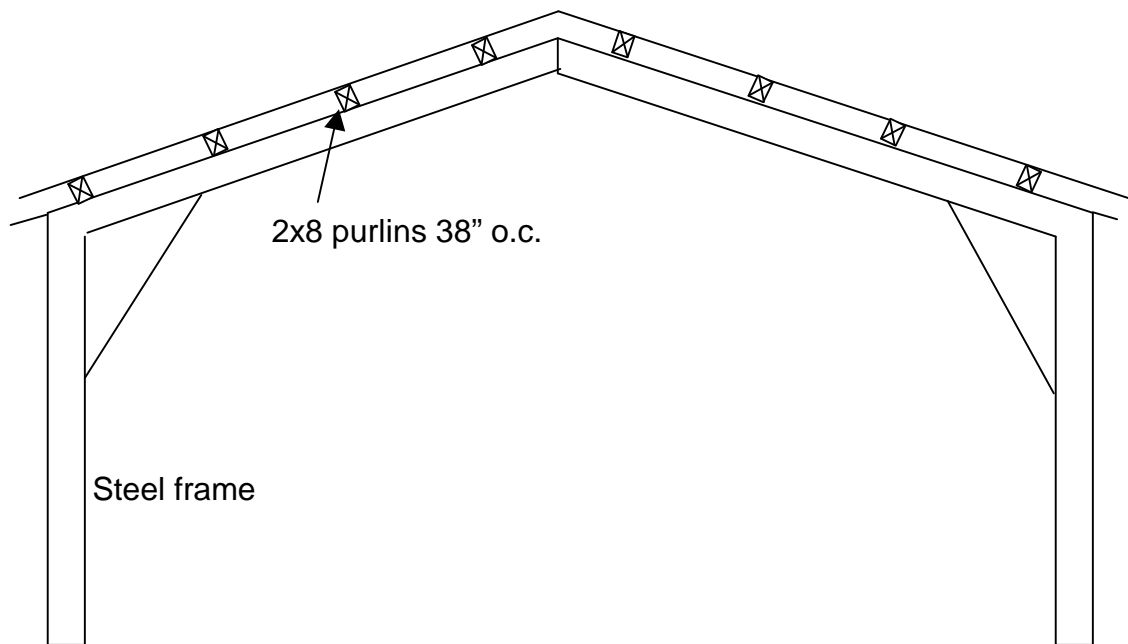
This building was a pre-engineered steel structure built in 1970 and was used as a freestall cow barn (Figure 6a). The barn had a north-south orientation. Although it was a steel frame building, 2x8 wood purlins, spaced 38 in. o.c., were installed on edge in lieu of steel purlins. The wood purlins clear spanned 16 ft. The measured sidewall height was 9 ft.

This building lacked any meaningful ventilation system. Consequently, a high-moisture environment existed in the barn. The purlins were visibly wet. Reportedly, the original galvanized roof had been replaced in 1987 due to advanced rusting.

The snowstorm resulted in an unbalanced snow load on the structure. There was heavy snow accumulation on the east-facing roof. Failure was avoided by shoveling snow off the roof. The owner noticed visible deflections of the purlins and consequently decided to remove the snow.

Figure 6a. Building cross-section for Case No. 4.

A mechanical or natural ventilation system should be installed in the barn to improve air ventilation. The orientation of the barn provides the opportunity to take advantage of the prevailing westerly winds but the relatively low sidewall height may not allow sufficient air to enter the building. A mechanical ventilation system would be more effective in this building. Plans should also be made to either replace the existing wood purlins with engineered metal purlins or install new intermediate wood purlins. The existing purlins (Figure 6b) given their size (2x8), span (16 ft.), spacing (38 in. o.c.) and in service condition (wet) are far from being adequate for the design load.

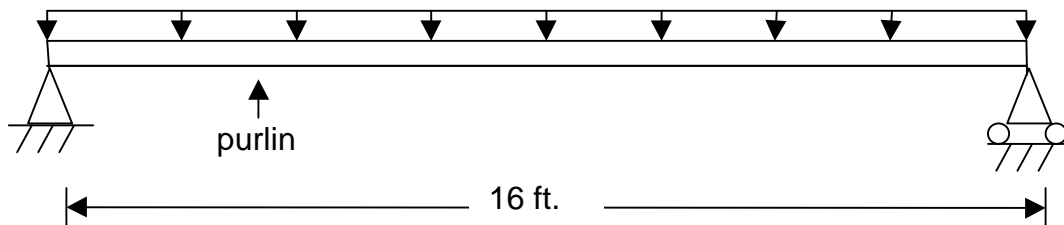
Figure 6b. Span of the 2x8 purlin.

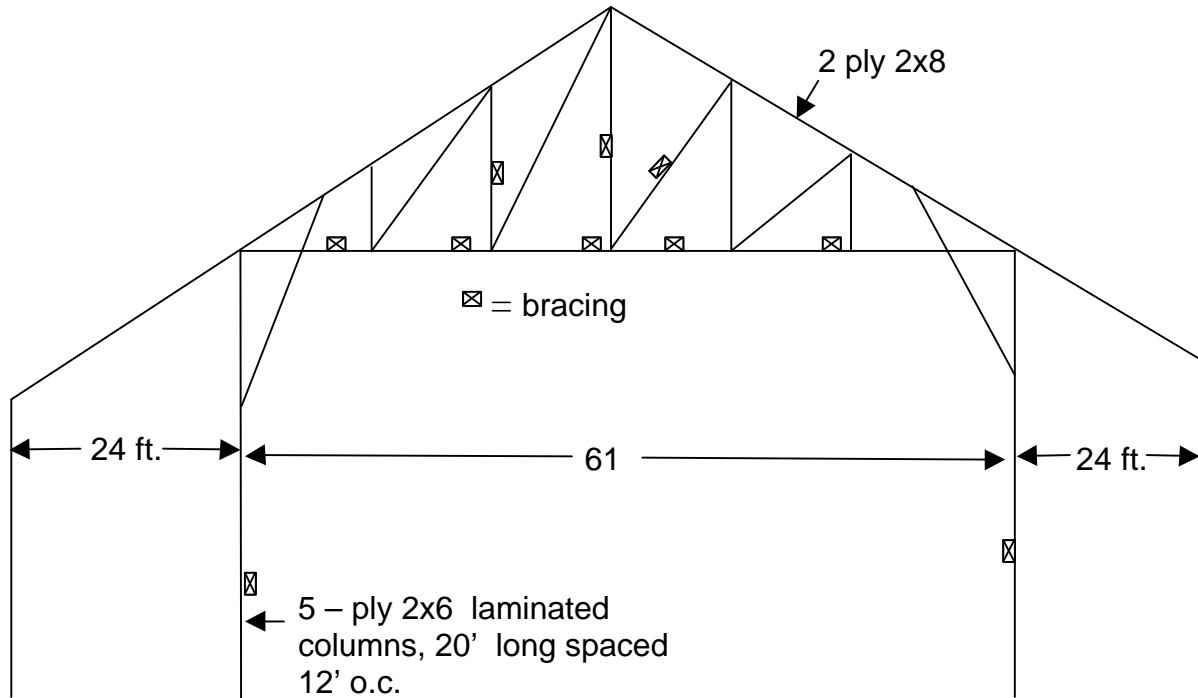
The building was well braced as shown in Figure 7. The bottom chords had sufficient lateral bracing members, and all long compression web members were adequately braced laterally. One end of each knee brace was connected to an intermediate post and the other end extended up to the truss top chord where it was properly connected.

Careful investigation of the remains of the failed laminated post showed that the center ply had a large knot located at the location of apparent failure. The posts were not laterally braced along the weak axis. Because of the visible buckling observed by the owner during the snowstorm, he braced the interior posts laterally subsequent to the failure of the one post. It seems that the post with the large knot failed and pulled down

on the truss that was connected to it. A split across the holes of the truss-to-post connectors (bolts) was visible perhaps due to racking effect. Nevertheless, the building appeared to be well designed as was exhibited by the fact that the failure was contained within one post/truss assembly.

Figure 7. Typical cross-section of Case No. 5.

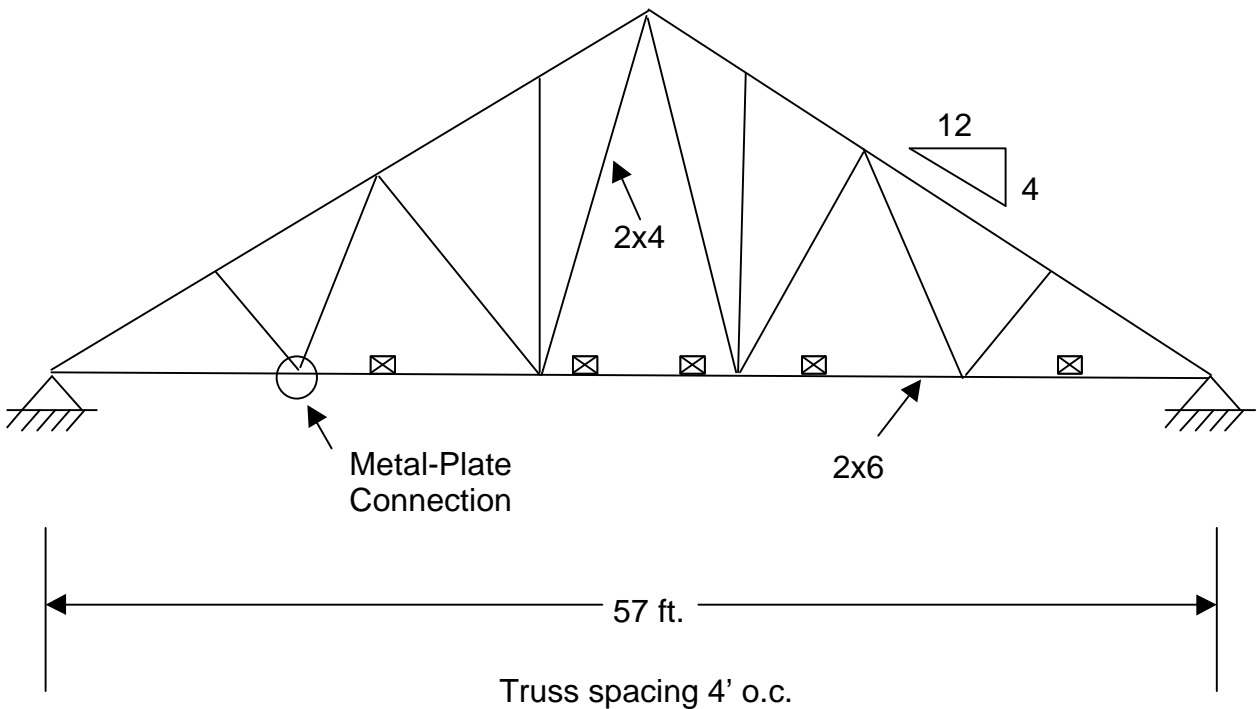
The configuration of the original center truss is shown in Figure 8. The truss spacing was 4 ft. o.c. The bottom chords were adequately braced laterally, but the compression web members were not.

Figure 8. Original center truss configuration for Case No. 6.

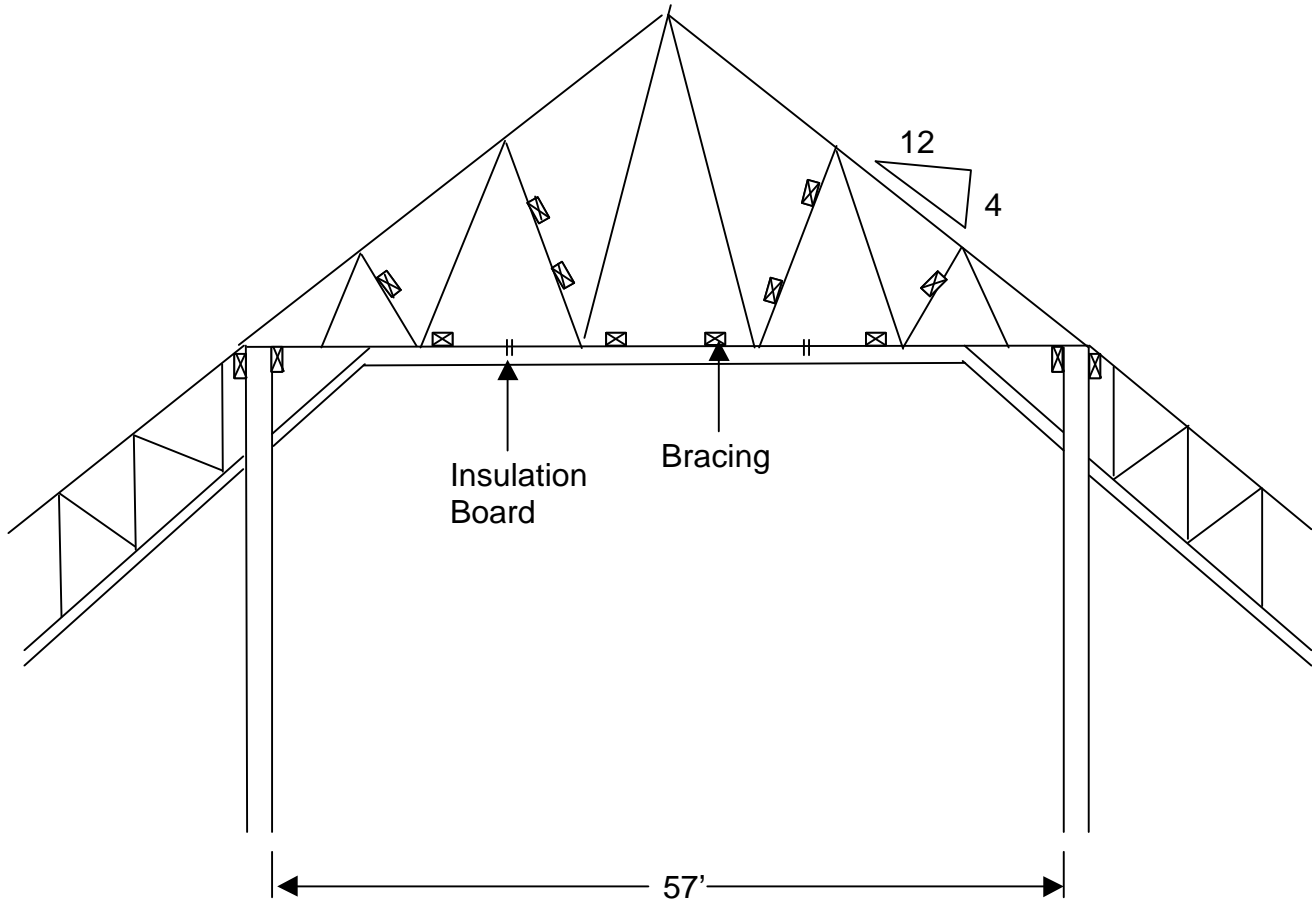
The configuration of the replacement trusses are shown in Figure 9. The new trusses were spaced 2.67 ft. on center (3 trusses per 8 ft.). Bottom chord, top chord, and web members were 2x6's, 2x8's, and 2x4's, respectively. Many of the new trusses were only toe-nailed to the horizontal header running between the posts. This type of connection may prove to be inadequate to withstand uplift forces caused by wind. Also, gaps between insulation boards (because of improper installation) will allow moisture migration to the attic space and become trapped within. As previously mentioned, this situation may be detrimental to the strength of the wood and the integrity of the connection as well as the deterioration of the insulation.

Figure 9. Replacement truss configuration for Case No. 6.

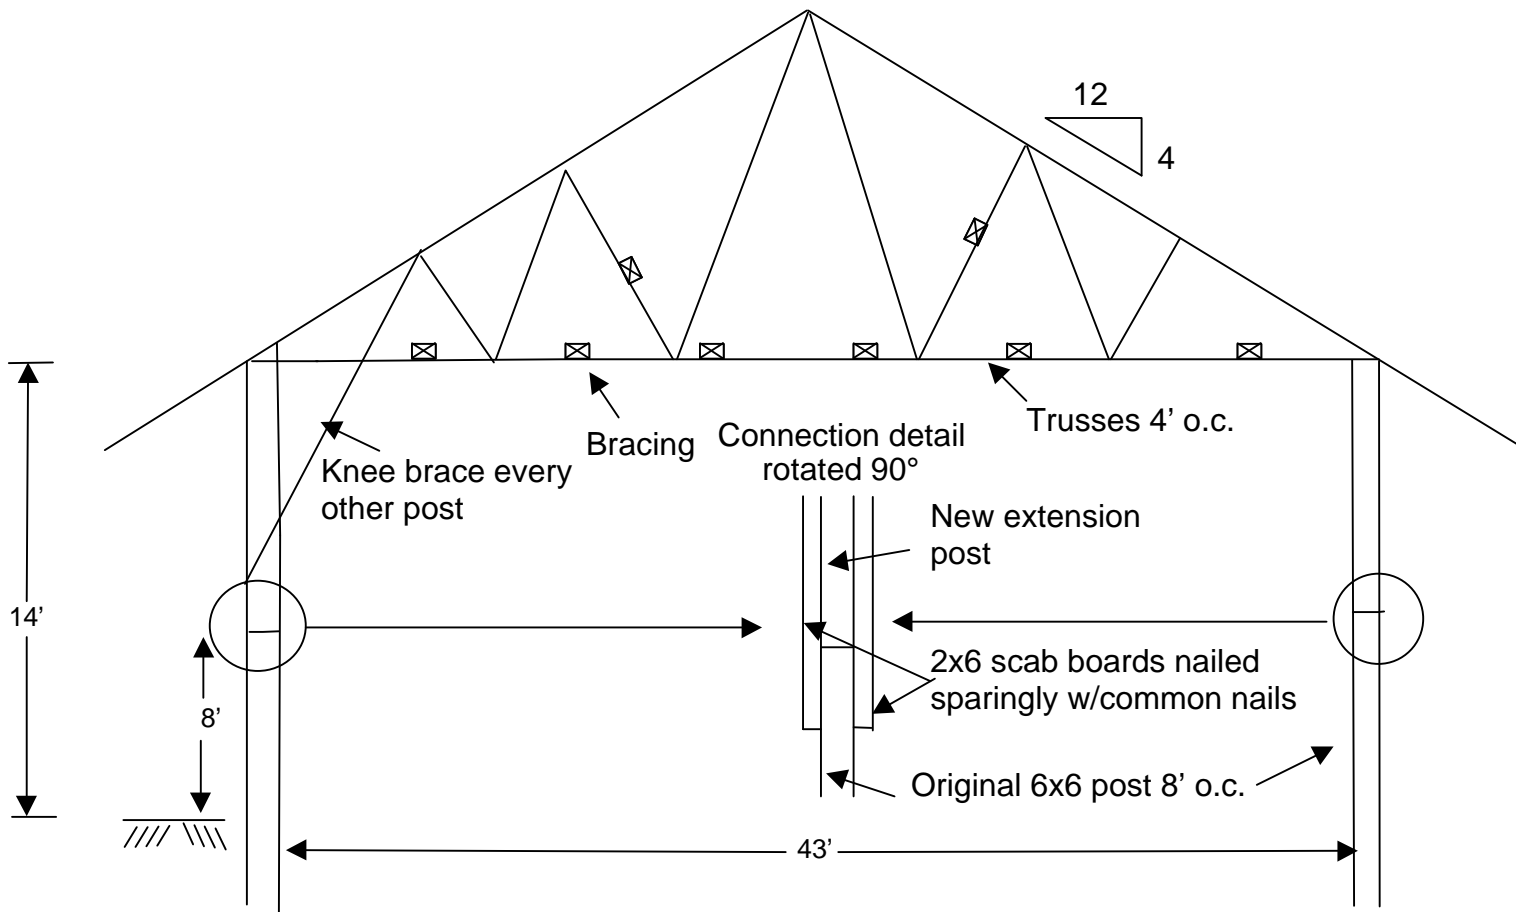
At the time of the visit, the remains of the collapsed building had been removed and a replacement building was almost completely constructed. The side wall height for the new building was increased to 14 ft. to improve natural ventilation by extending the original post by another 6 ft. The details of this connection are shown in Figure 10.

As stated previously, the original 8 ft. high posts were extended to 14 ft. To increase the sidewall height by 6 ft., a new 6x6 post was placed on top of the original 6x6 post and held in place by two - 2x6 scab boards nailed sparingly to the post with common nails. The method of connection and the materials used is marginal at best.

Figure 10. Cross-section of rebuilt barn for Case No. 7.

The new posts used on the left wall of the building extended all the way to the top chord and the trusses were face nailed to the posts. The posts on the right wall however, were not extended to the top chords. The trusses on this side of the building are toe nailed to the header. From casual observation, the latter connection seems to be inadequate to resist uplift forces.
